# Comparison Between Genuine DENSO and Fake Spark Plugs

## Comparison of DENSO and Fake

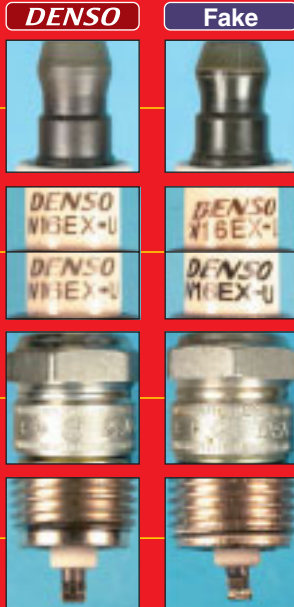
### Appearance

**Terminal**  
Terminal has a glossy finish.

**Markings**  
Printed wording can be scraped off.

**Housing**  
Poor surface finish.

**Screws & Electrode**  
Poor thread quality and finish.

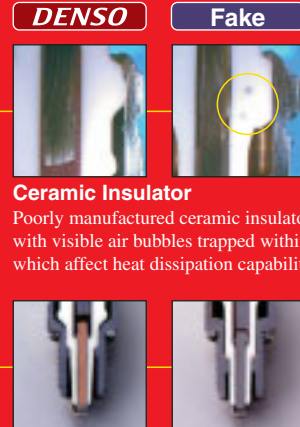
### Section

**Ceramic Insulator**  
Poorly manufactured ceramic insulator with visible air bubbles trapped within which affect heat dissipation capability.

**Center Electrode**  
A genuine DENSO spark plug has a copper-core center electrode with excellent heat conductivity. A fake DENSO spark plug does not, retaining heat that causes meltdown.
